VIMS Living Shoreline Design Training for Marine Professionals

Living Shoreline Design Training

Project Design Discussion

Robin Grove Park Town of Colonial Beach

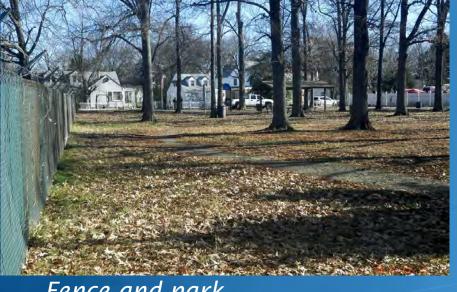
Fence and park

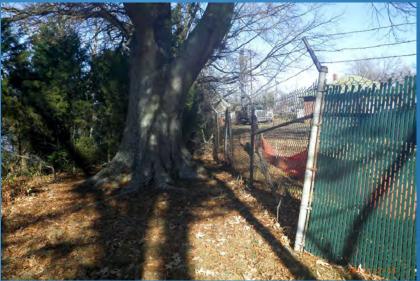
Shoreward fence and wooded bank on Northwest facing shore.

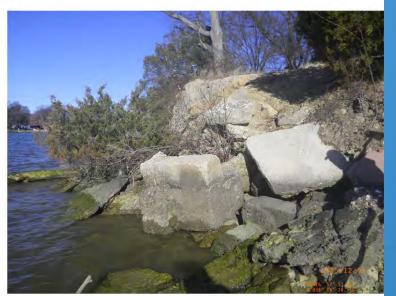
Cross-section C-C' Broken Concrete Debris
