# Living Shoreline Professionals Advanced Training

**LIVING SHORELINE PROFESSIONALS  
ADVANCED TRAINING  
AUGUST 2017**

**GROUP DESIGN EXERCISE**

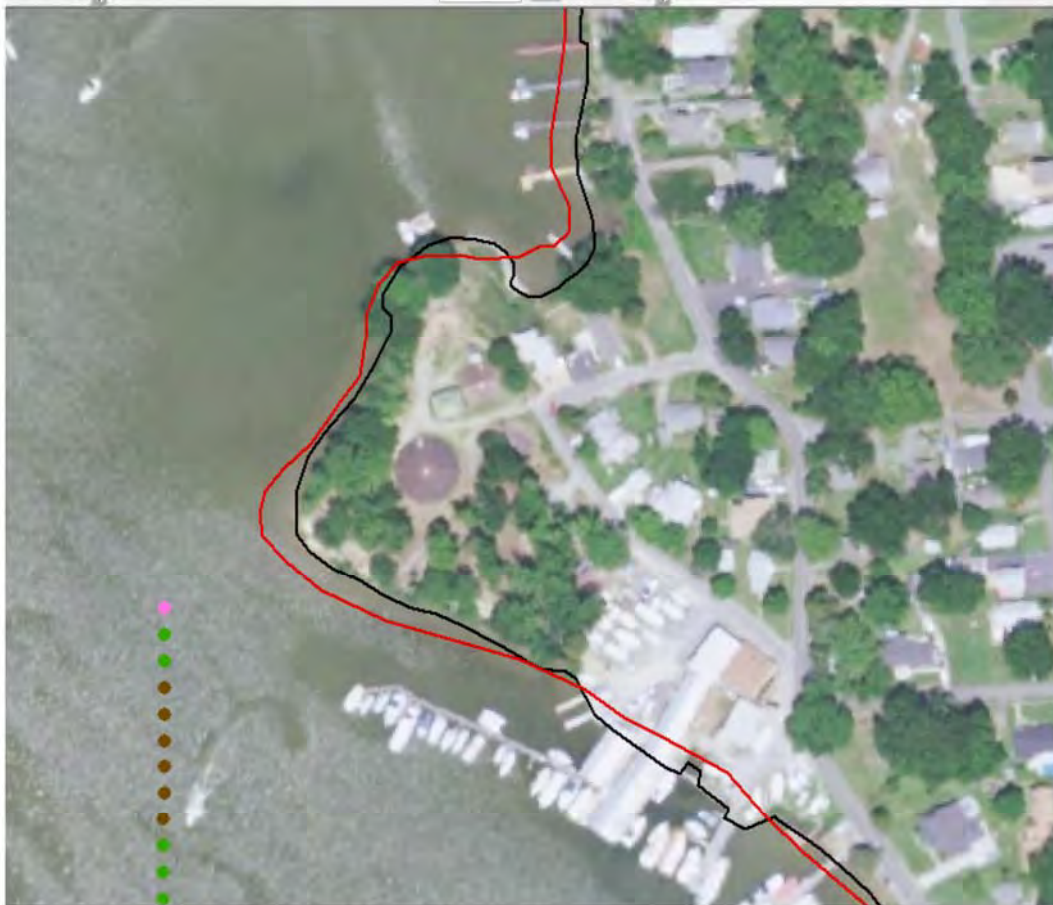
# Shoreline Change

From the Shoreline Studies Shore Evolution Database

Shore Change Data: 1937 to 2009

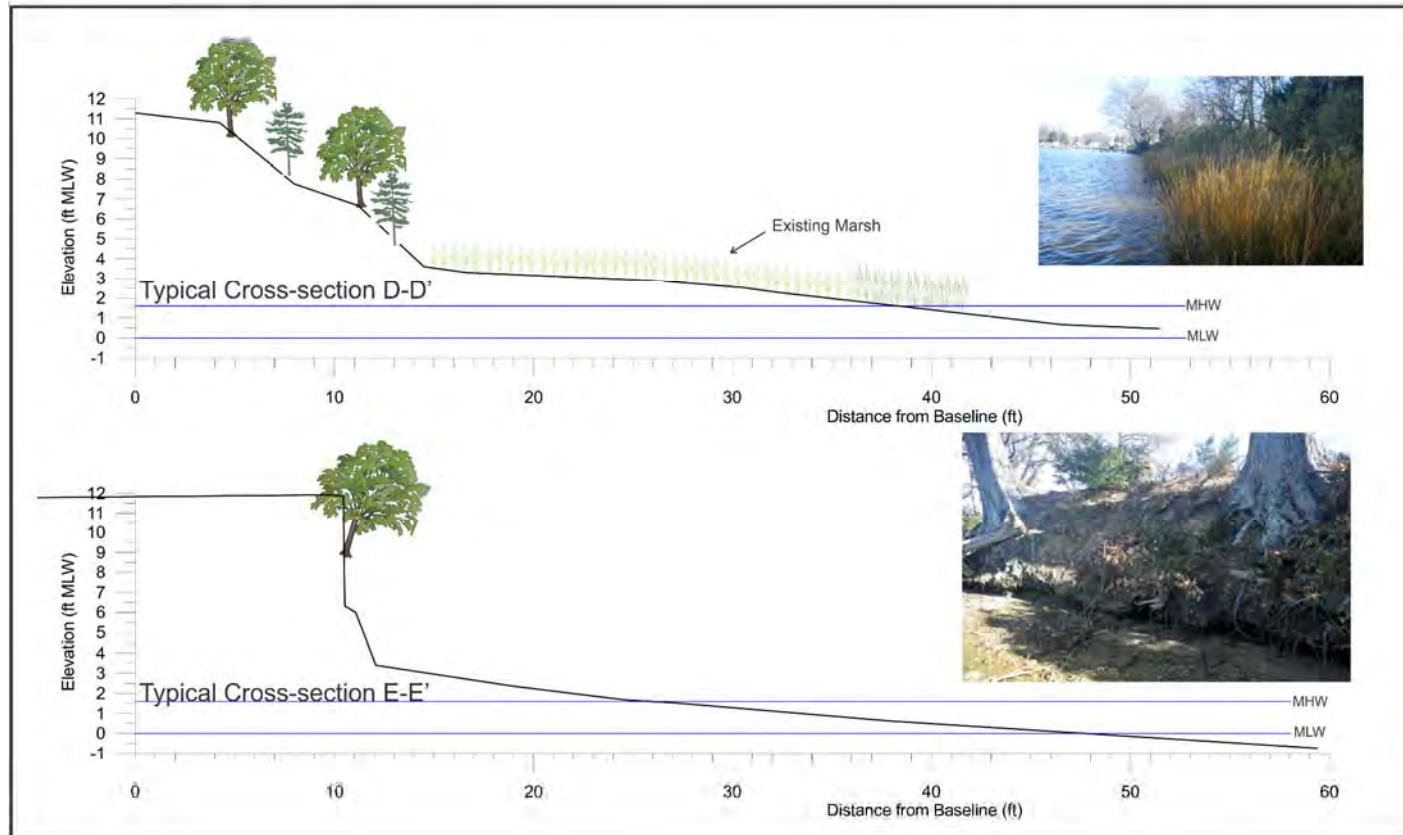
# Cross-Sections from Survey

These cross-sections show the elevation of the bank, shoreline, and nearshore, information needed to design a shore protection system.

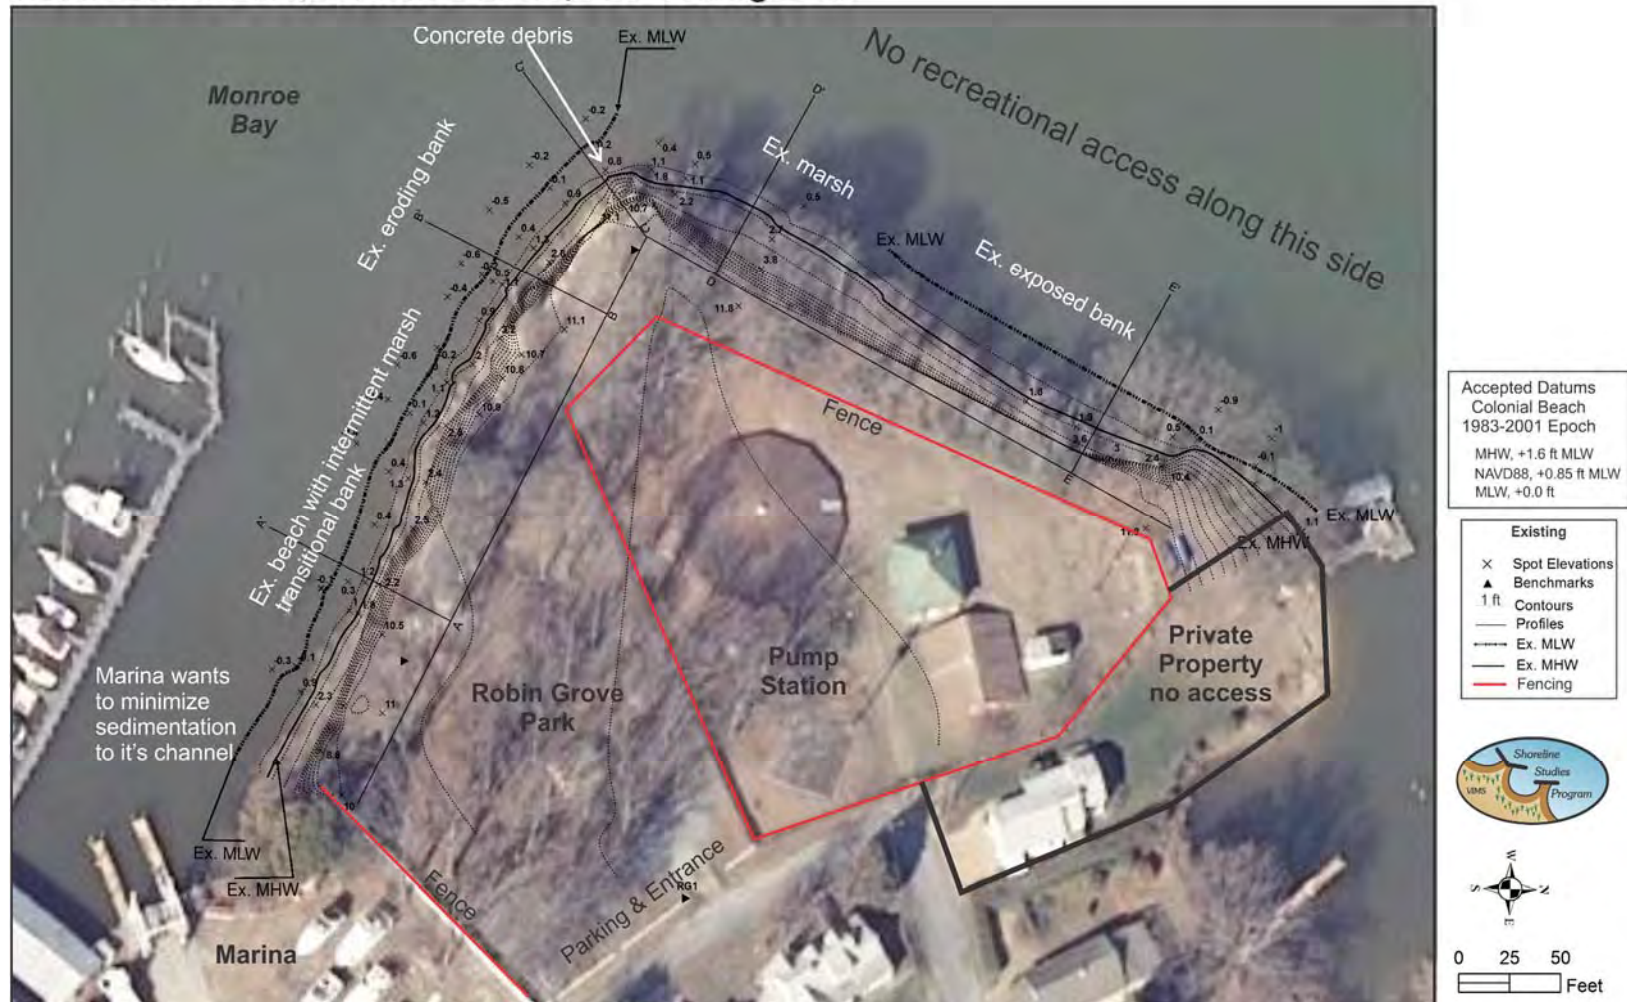
# Information Helpful for Design

Robin Grove Park, Colonial Beach, VA Existing Data

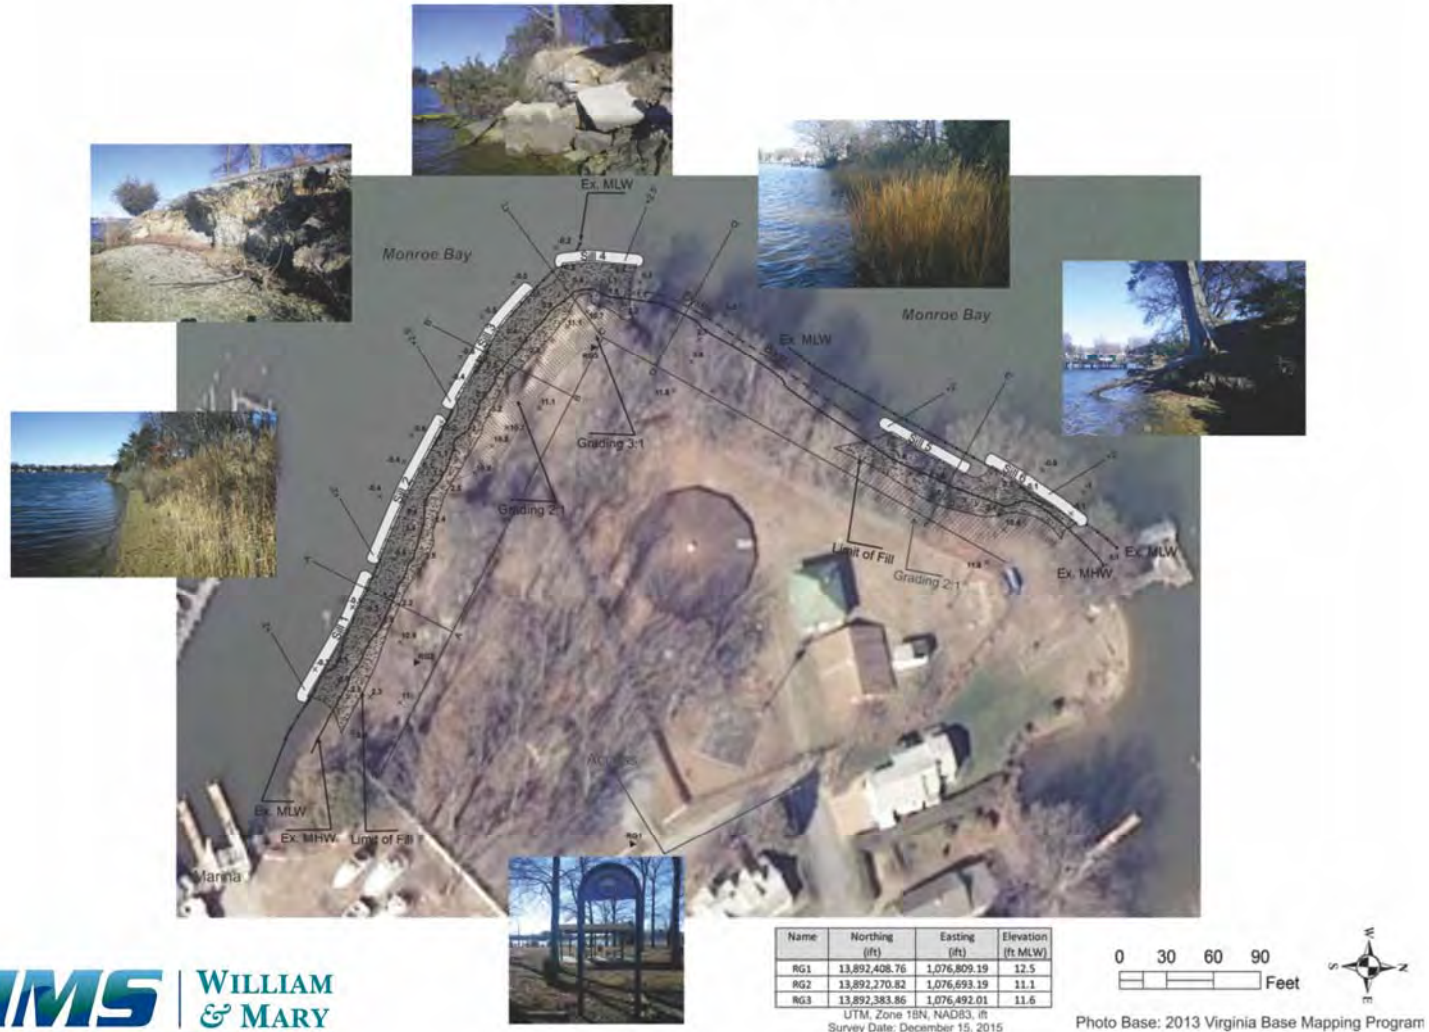
# One Plan

The plan consists of six rock sills with planted marsh, oyster bag sills, and bank grading. Sills are relatively narrow and low since the site has relatively low fetch conditions. Bank grading will correct unsafe conditions and provide recreational access. Construction access to the northwest facing shoreline may be an issue that would have to be worked out by the County with the treatment facility and private landowner.

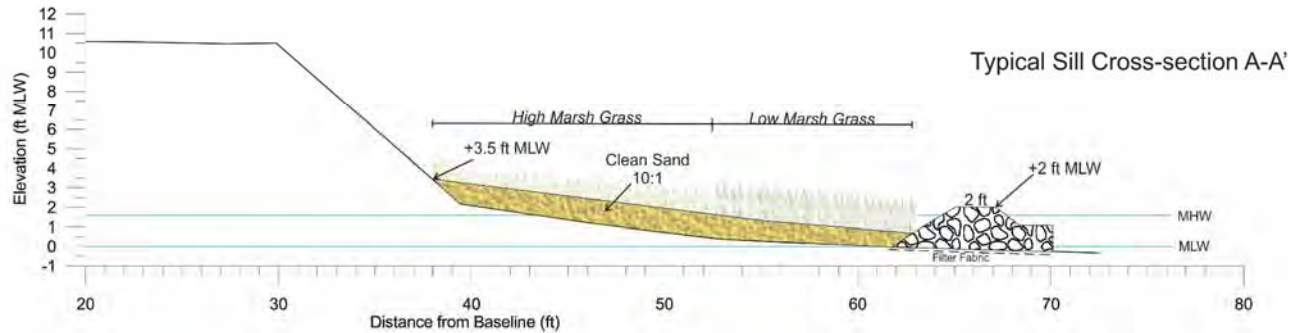
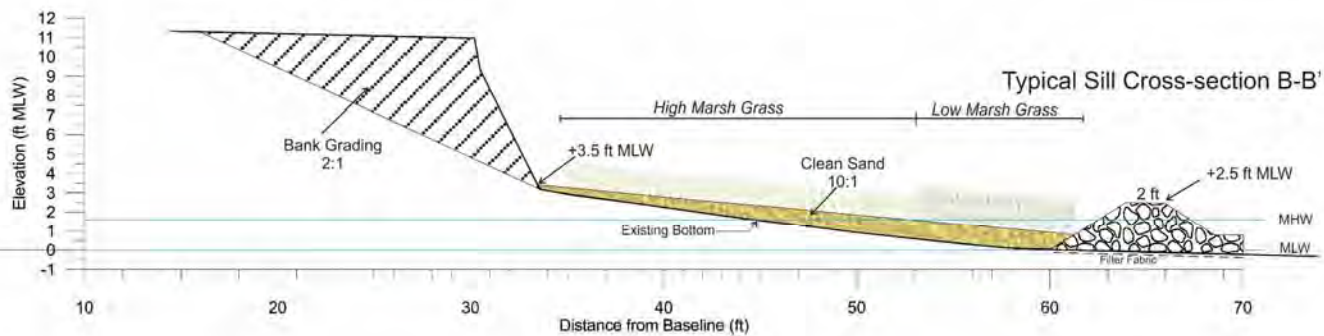
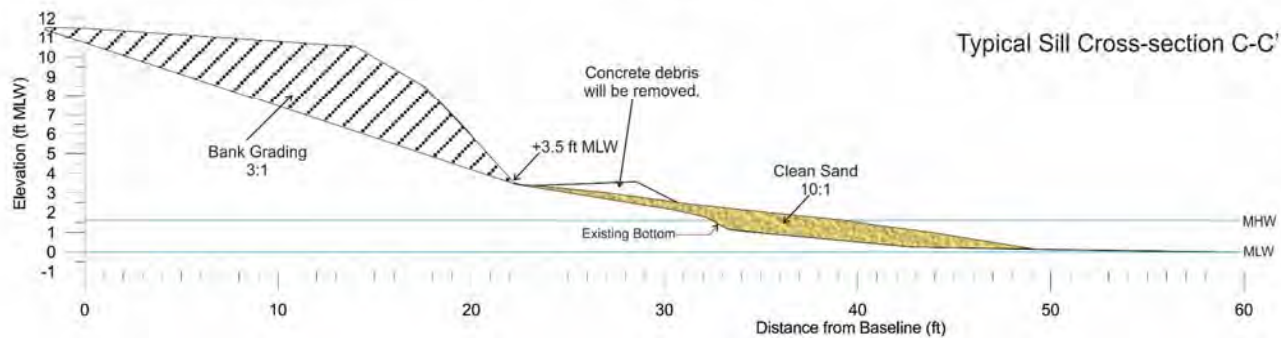
# Typical Cross-Sections

To protect the base of bank near the marina channel, a low, narrow sill with sand fill is designed for the southwest facing shoreline. Moving toward the point, the structures become taller to deal with additional fetch. Because the steep eroding bank is a hazardous condition, the shoreline is graded. At Robin Grove Point, the concrete debris will be removed, and clean sand will be placed in a gap between the structures. The bank will be graded on a 3:1 slope to provide easier access to the beach for people with their pets and a kayak/canoe launch area.

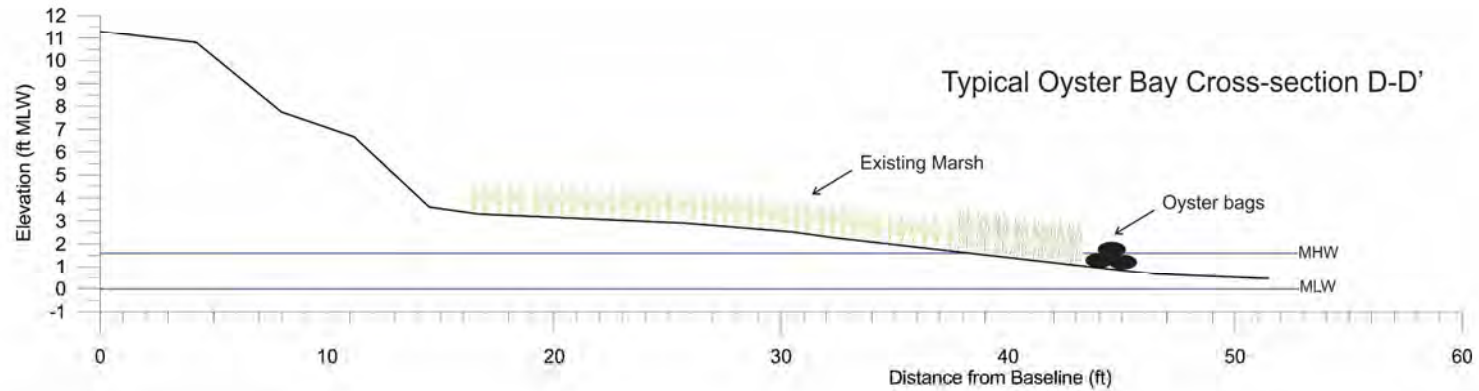
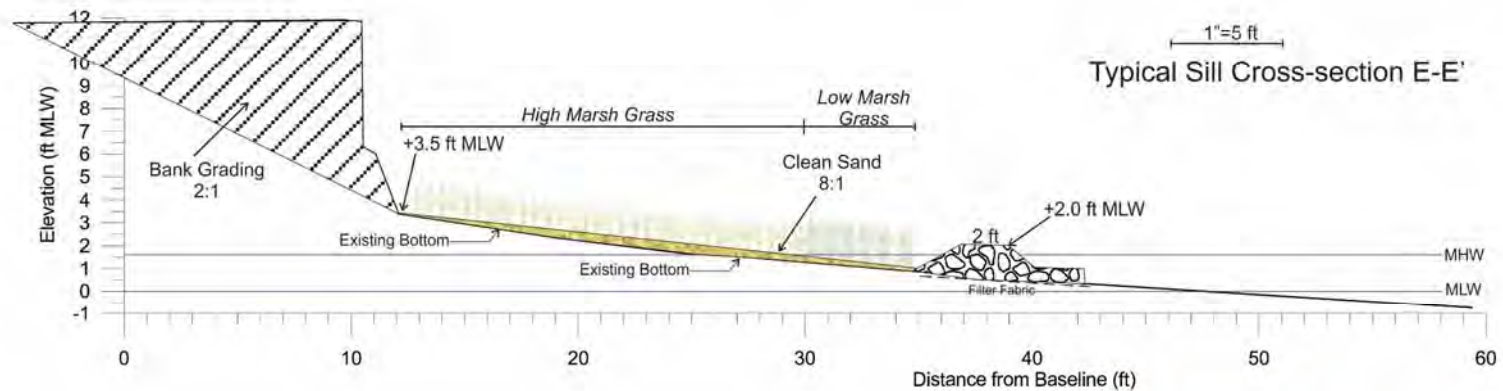
# Typical Cross-Sections

The marsh on the northwest facing shoreline is stable. However, to maintain it, oyster bag sills will be placed along its edge. The heavily wooded shoreline is not easily accessible for people to use and has fallen trees and exposed roots that make it unsafe. A low rock sill with sand fill will establish a marsh for shore protection and the bank will be graded. Construction access may be an issue for this section of shoreline.
